Mercotronic Model 98 Schematic Correction Mar 23 2023

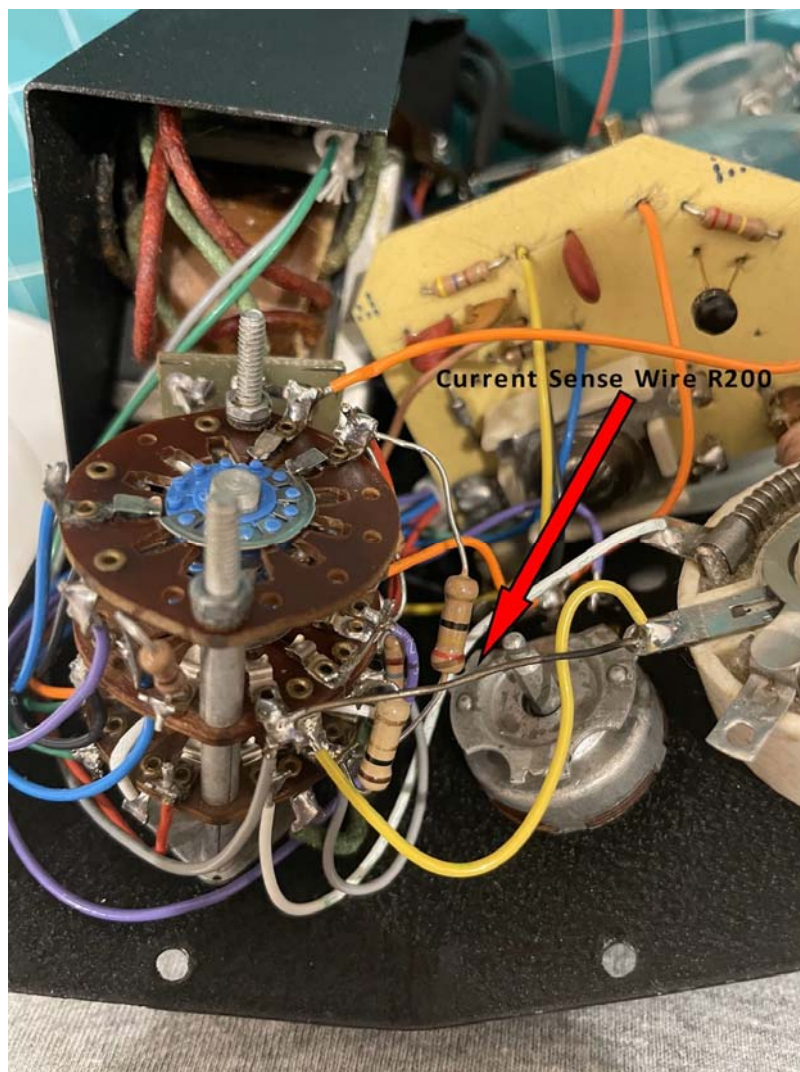
On the Model 98 that was documented there is only one piece of this special wire used – the Model 9800 uses two pieces. On the Mercotronic Model 98 the piece, which I have labelled R200 in the corrected schematic, connects between the Lo – Hi Control VR100 terminal 2 and the test selection switch (SW100 section D) terminal 22. My guess is that this piece of wire was used to calibrate the meter during coil test so it displays the proper amount of current flow. If someone has a Model 98 that

The actual physical connection points for R200 are VR100 Terminal 2 to SW100D Terminal 22

Picture of the wire at the two connection points

requires a repair of either of these components we would advise that this special wire should be made note of as far as length between the connection points at each terminal and reused and connected at the same spots on the wire to a replacement component. When removing a component unsolder and unwrap the wire from the terminal. DO NOT CUT THE WIRE as it will be difficult to splice back together – easy to make shorter – much harder to make it longer again! Since the resistance value of the wire is unknown and is such a small value that it cannot be measured with a normal ohm meter it may prove very difficult to replace the original wire if it gets damaged or shortened.

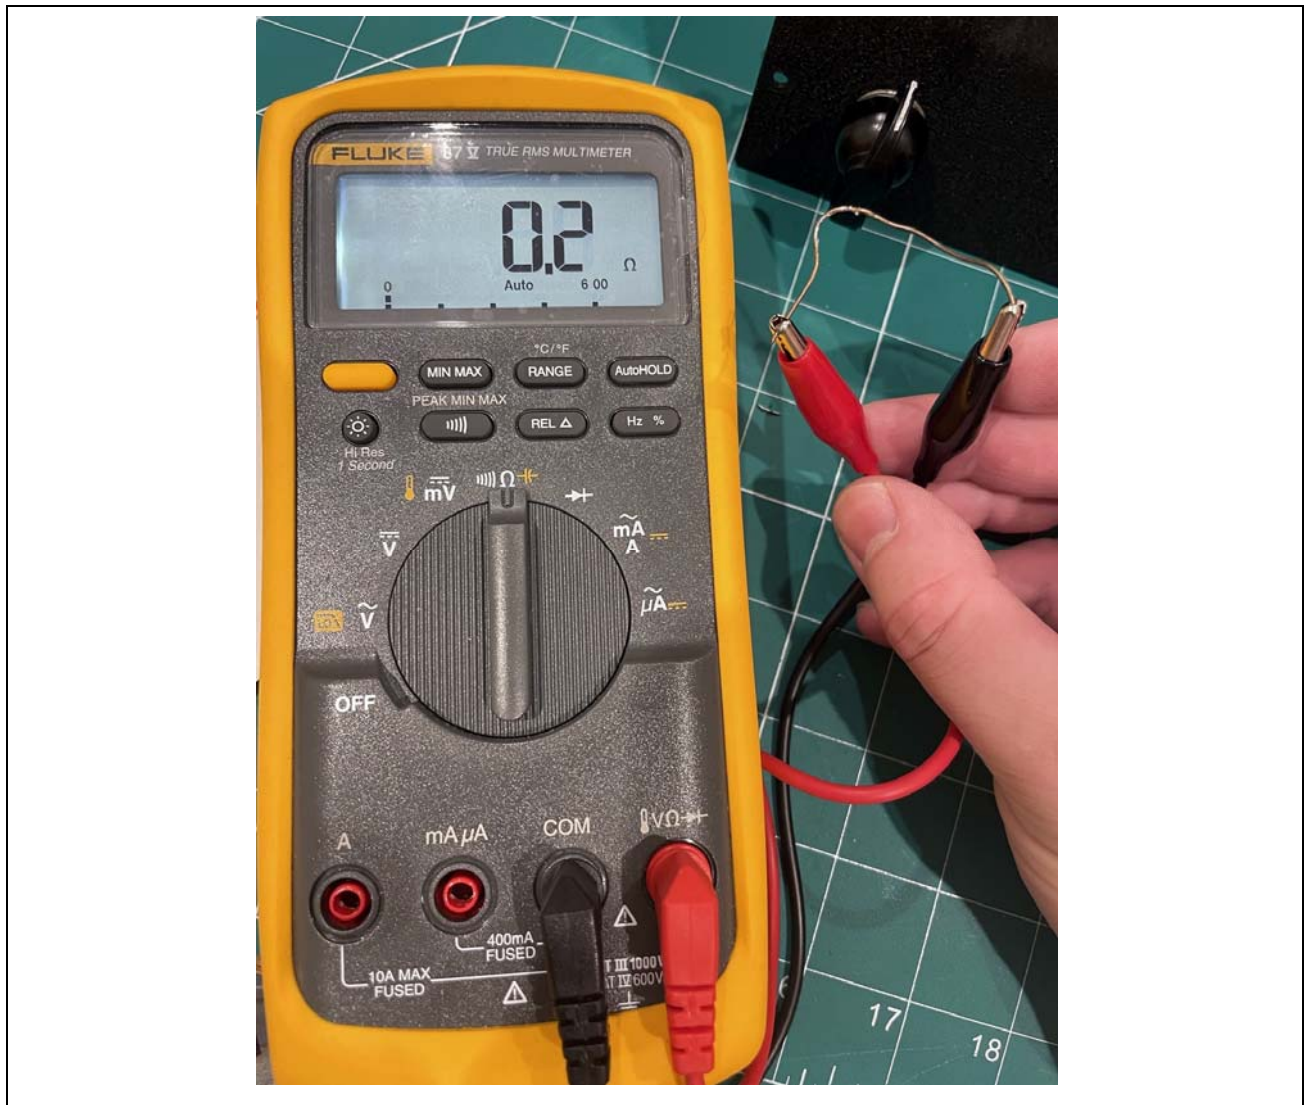
He used an ohm meter to try to measure the resistance level of the original wire but his ohm meter displayed it as 0.2 ohms which was the same reading that he would get if he measured the new replacement wire, any other normal wire or by shorting the leads together. As it turns out that during the manufacture of some of the Mercotronic units (such as the Model 98 and Model 9800) a special piece (or pieces) of wire was used as a connection wire at some point between the Lo – Hi control and the wire that comes from the vibrator socket that connects to one of the function switch terminals. The special wire is what we will call a “resistance wire” similar to what might be found in a heating element. The value of this wire is unknown at present – an educated guess on my part would give it a value of perhaps 0.01 ohms. Its purpose is to act as a very low ohm value “shunt resistor” across the positive and negative terminals of the meter. Whenever a current flows through a resistor there will always be a slight voltage drop between the two connection points of the resistor. This voltage drop will increase as the amount of current flowing through the resistor increases. In this case the voltage drop is very minimal and does not affect a coil under test but it provides a potential voltage difference between the meters positive and negative meter terminals and this creates a current flow through the meter resulting in a reading to be displayed by the needle and this reading will increase as the current flow through the wire increases. Now we know how the meter on the Model 9800 and the 98 works which is one more piece of the puzzle solved.

Trying to measure with an ohm meter

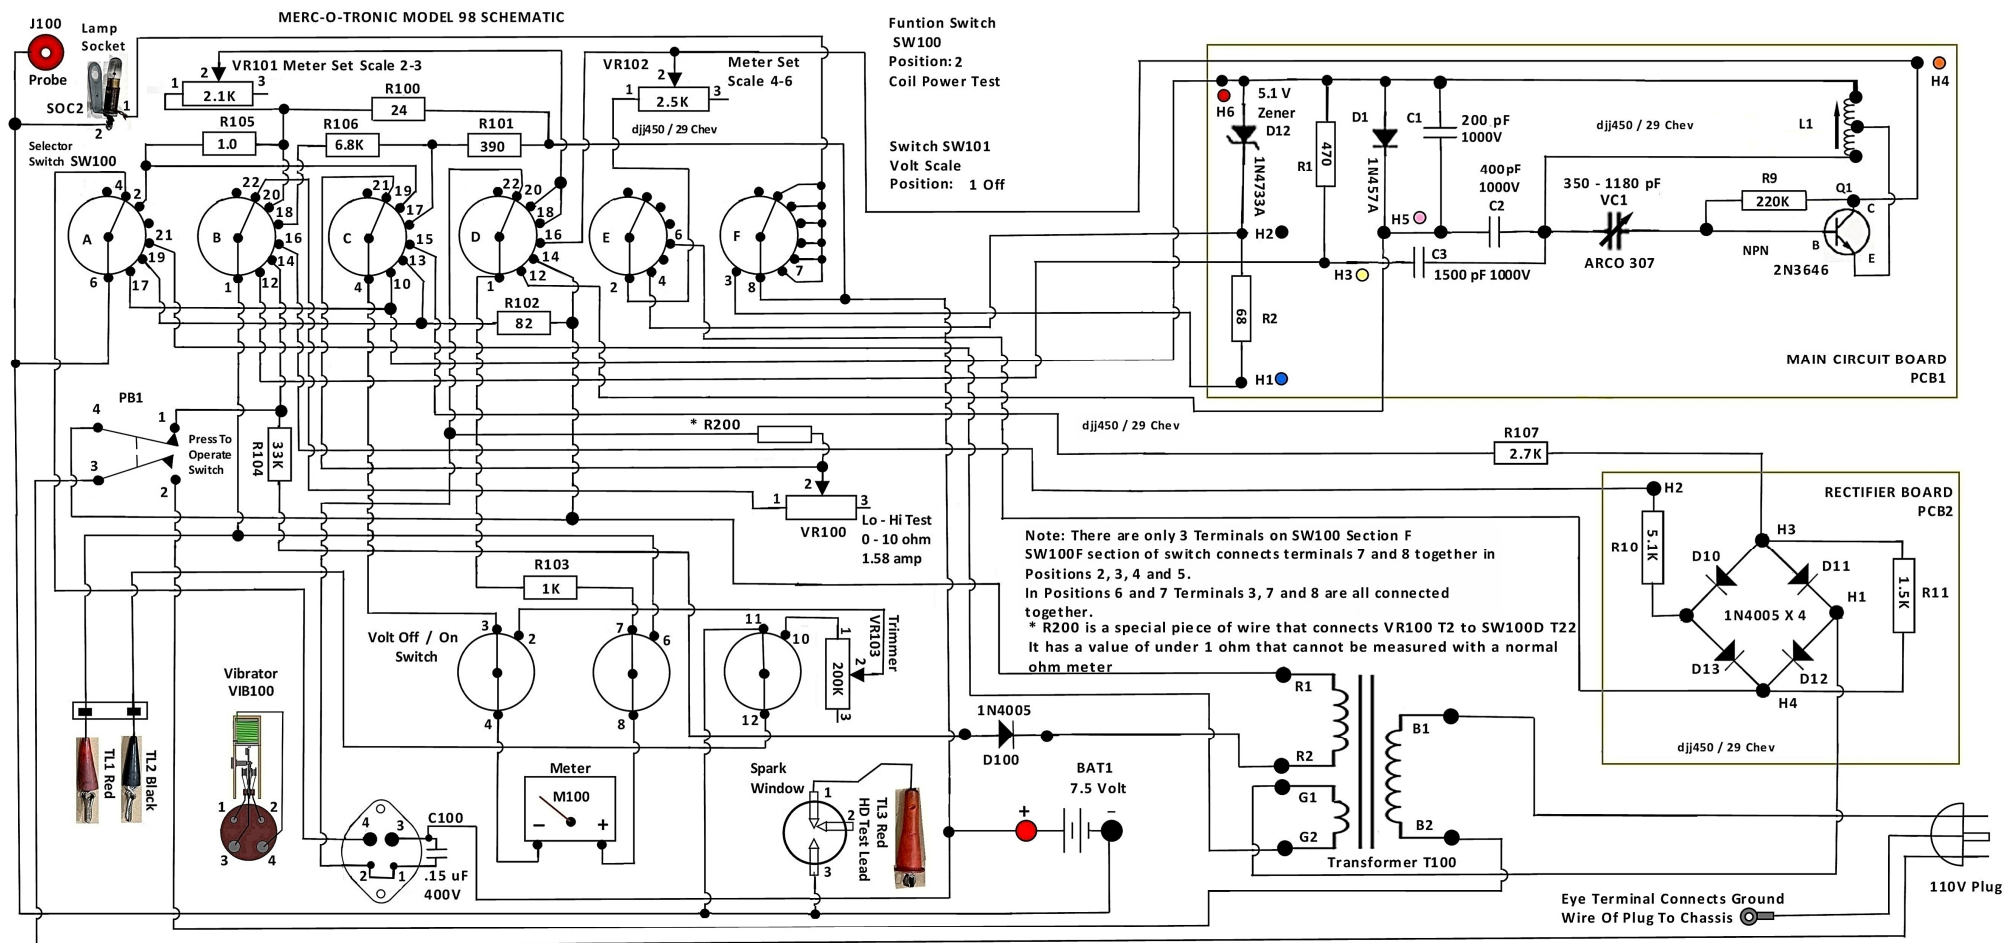
Attached is a corrected version of the schematic – the physical connections shown are not quite shown accurately but electronically the circuit is accurate.
